NASA Technical Memorandum TM 107554

Debris/Ice/TPS Assessment And Integrated Photographic Analysis For Shuttle Mission STS-52

December 1992

Gregory N. Katnik
NASA/Kennedy Space Center

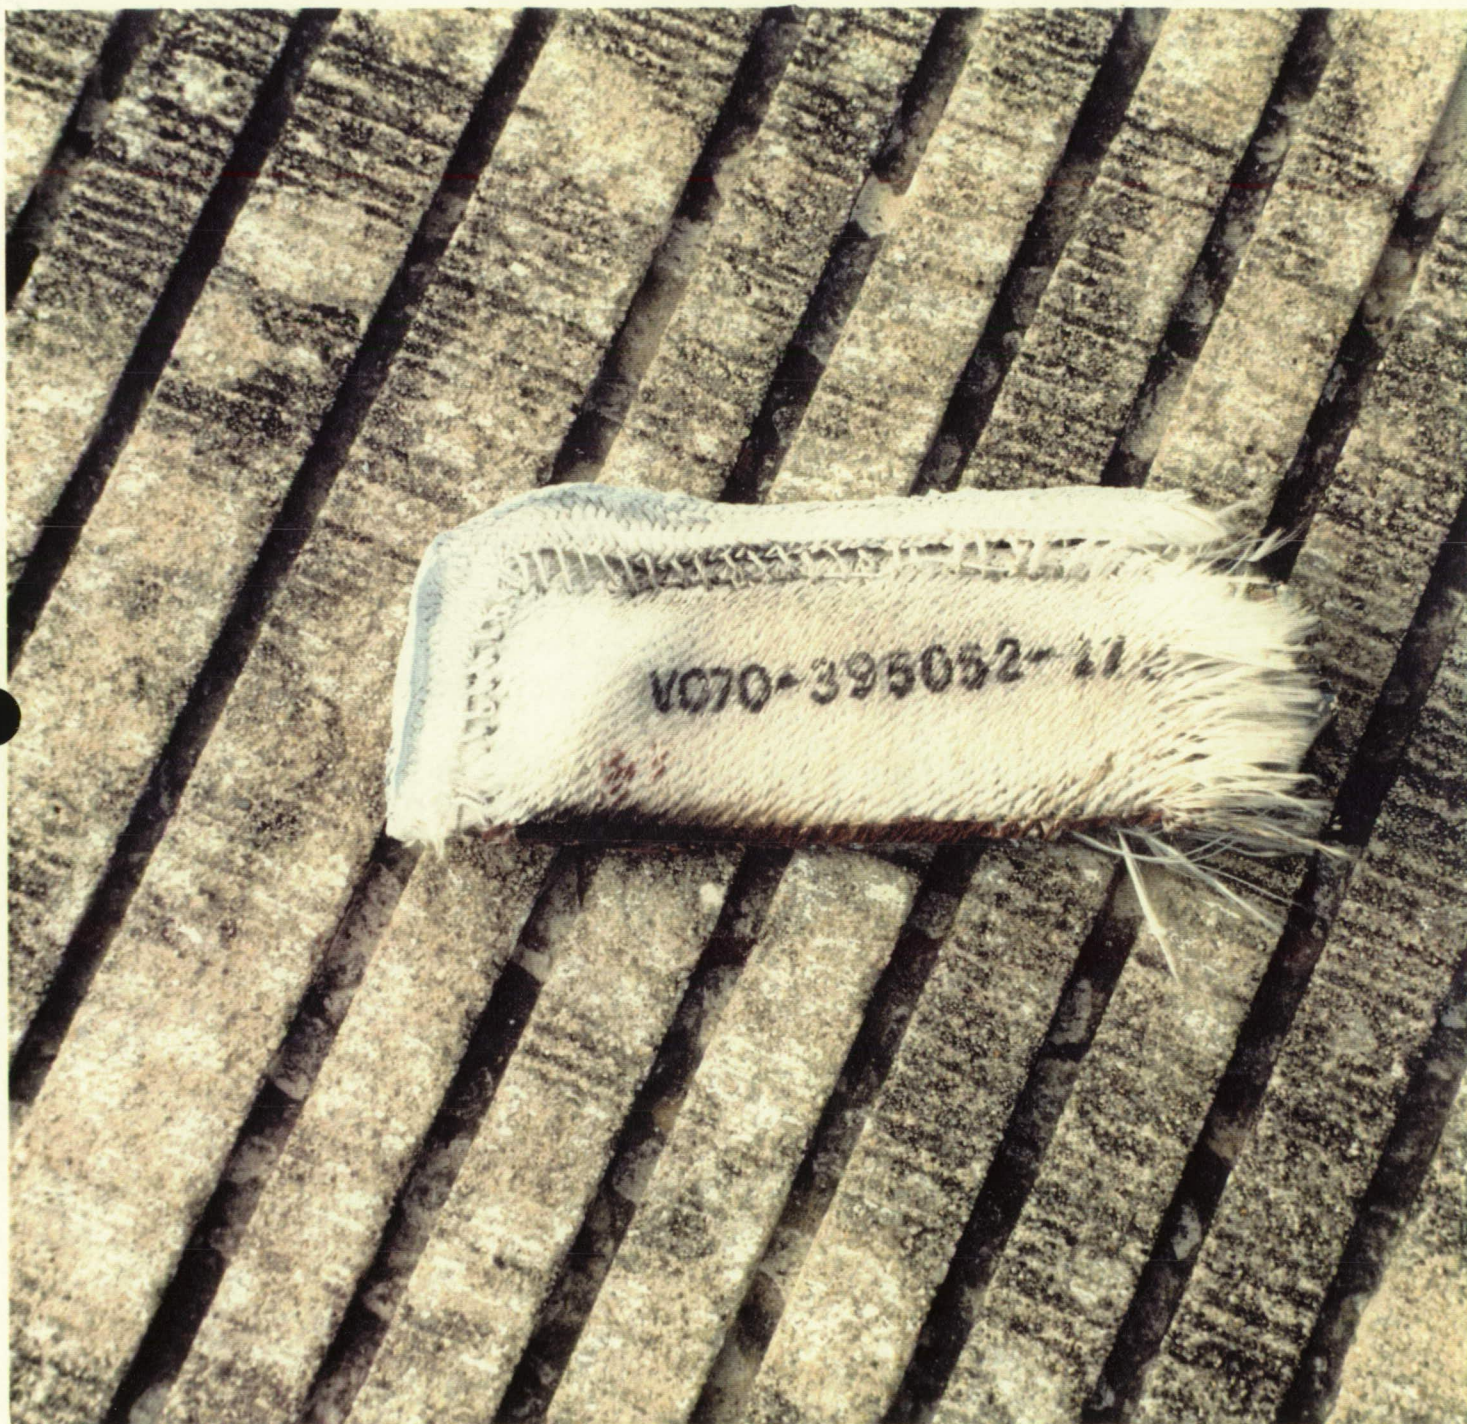
Hazing on the Orbiter windows was light and considered to be less than usual. A large number of tile impact sites (72 with 2 larger than 1-inch) occurred on the perimeter tiles around the forward facing windows. Most of the hits were small and shallow in depth.

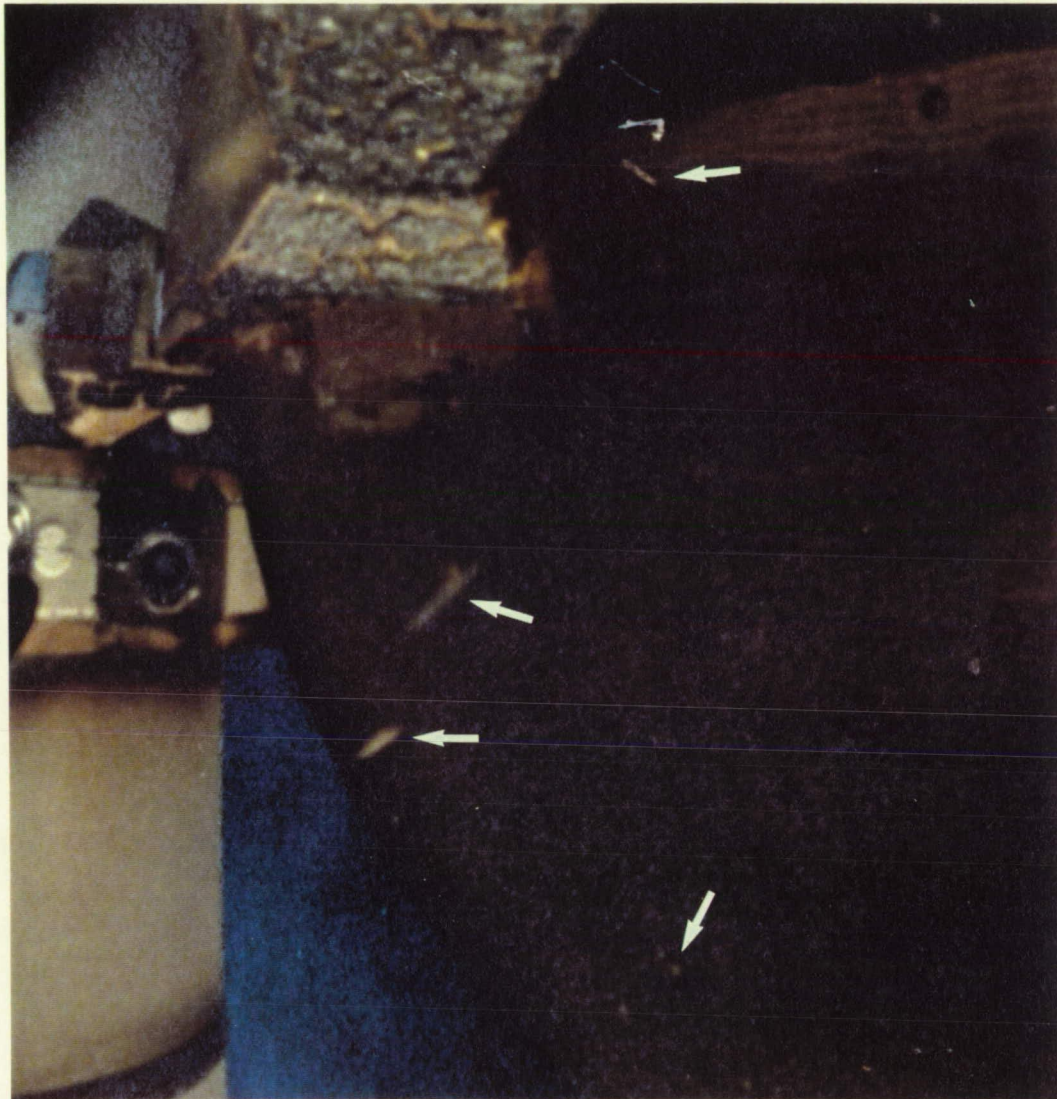
Figure 2.4.1.1 16 mm View (10 mm Lens) of LSRB Separation

Separation of the LSRB from the external tank appeared normal on the 16 mm umbilical well film views. No anomalies were observed on the LSRB surface areas. Multiple divots and chipped areas were visible on the base of the electric cable tray. A nearly square-shaped piece of light colored debris was noted approximately 3 seconds prior to the SRB separation. A dark, irregularly-shaped piece of debris was seen to come from behind the electric cable tray at approximately 2.4 seconds prior to the separation. A smear appeared in the upper left corner of the field-of-view at approximately 0.88 seconds prior to separation (5 mm camera film). The aft ET/Orbiter attach brace and the ET aft dome show charring similar to that seen on previous mission umbilical films.

Numerous pieces of small debris were seen in the 16 mm umbilical camera film views of the LSRB before, during, and after SRB separation. The debris appeared to be small pieces of TPS that had ablated off the external tank.

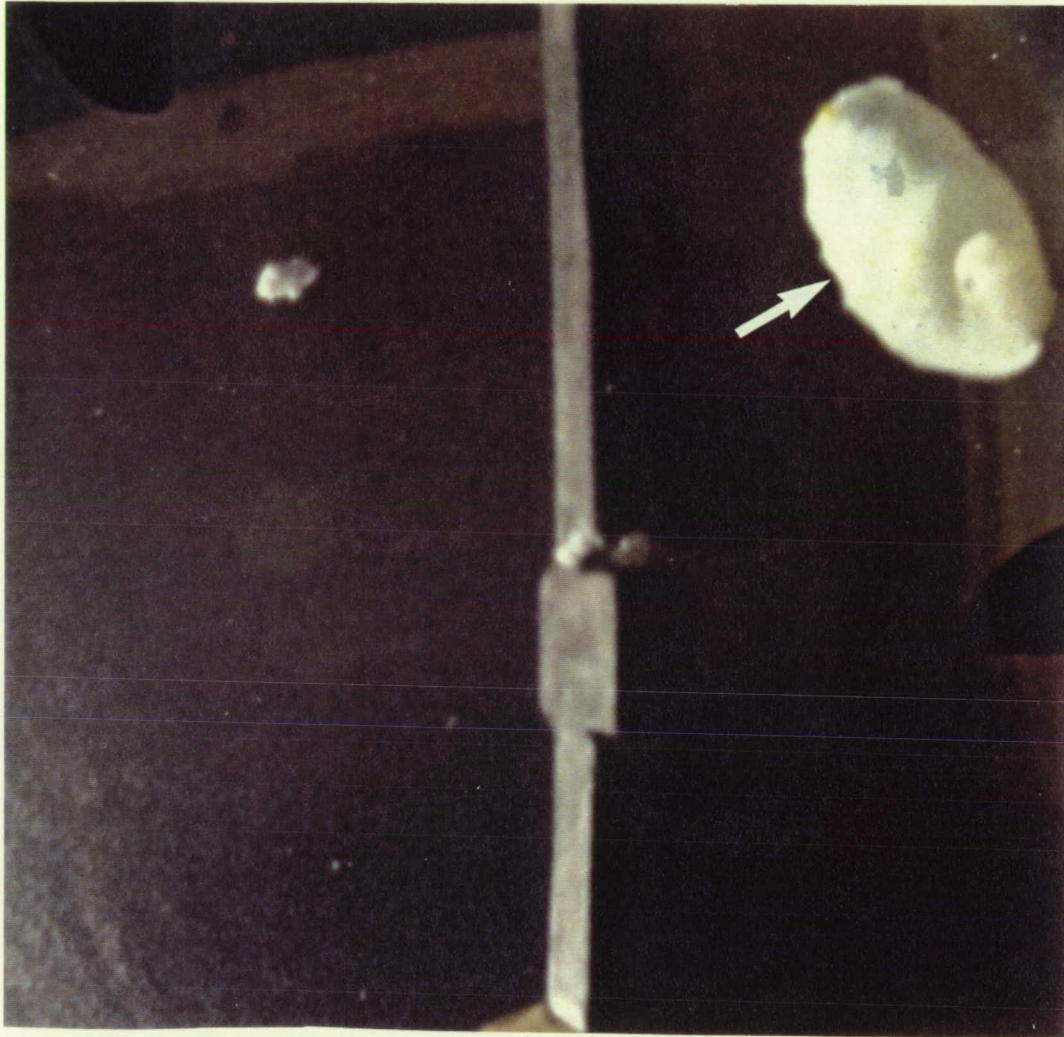
Figure 2.4.1.2 (A) Ice from Forward Purge Vent Tube Visible at ET Separation

A single, large, white cylindrical-shaped piece of debris was seen to travel across the FOV just before ET separation. KSC reported that this debris was an ice finger from a forward purge vent tube.

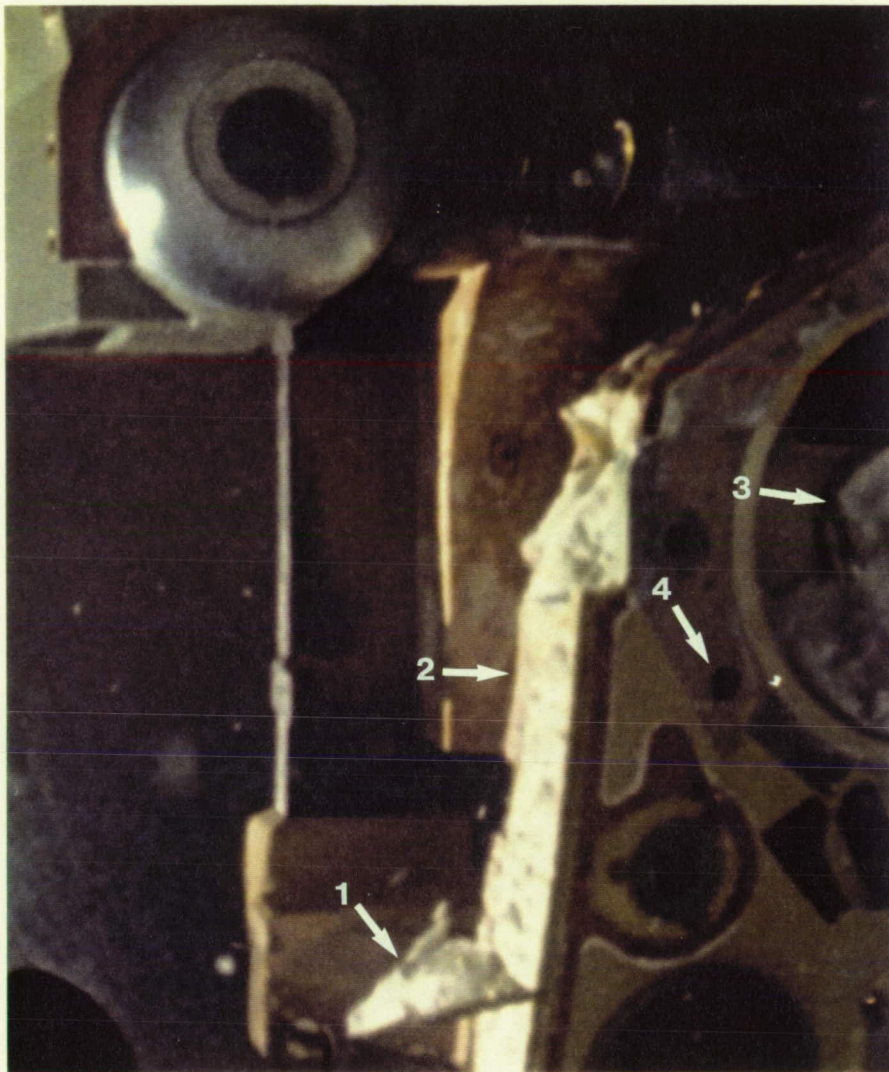
Figure 2.4.1.2 (B) LH2 ET Umbilical at ET Separation

A small piece of foam like material moved across the ET LH2 umbilical just after ET separation (1). A blistered appearance to the TPS on the left side of the LH2 umbilical was visible as the ET began to move away from the Orbiter (2). Ice was visible in the orifice of the LH2 17 inch line as the LH2 umbilical came into full view (3). The bushing sleeves appeared to be present in their proper positions (4). (The cylindrical-shaped debris object seen on the STS-40 umbilical well film was believed to have been a dislodged bushing sleeve).

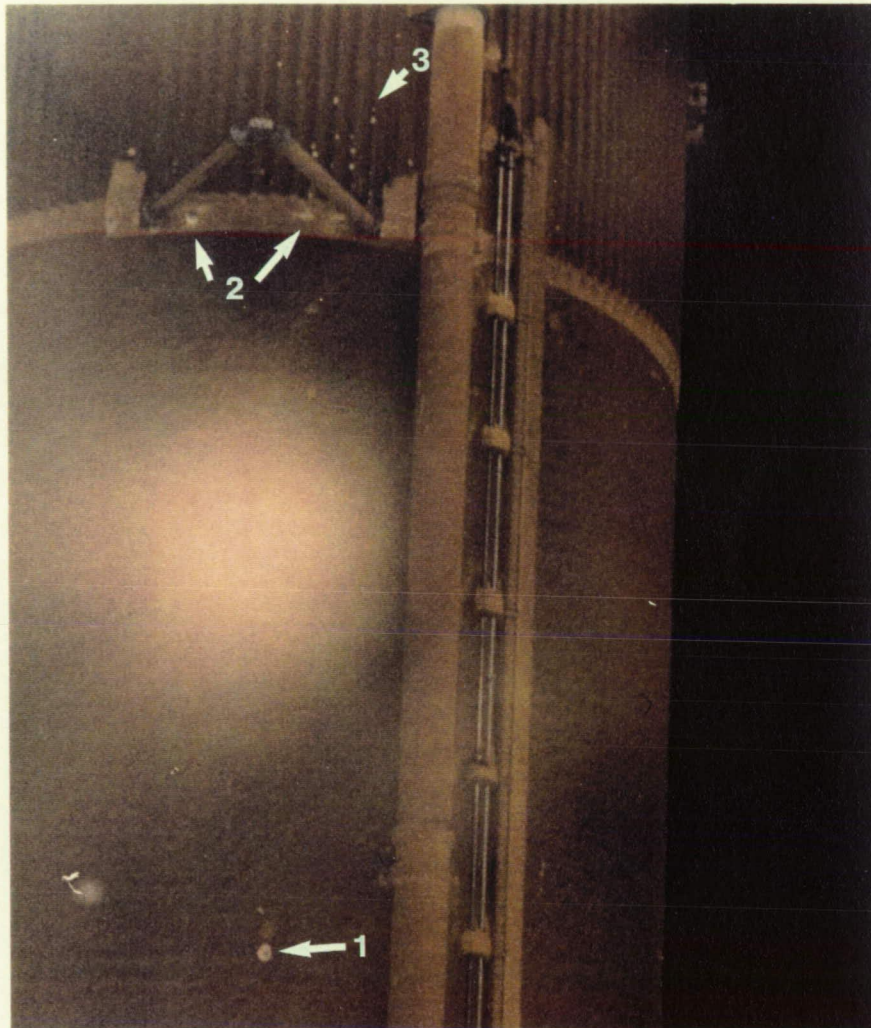
Figure 2.4.1.3 Small White Marks/Divots seen on ET +y TPS

A divot was seen on the LH2 tank TPS approximately ten feet below the intertank closeout line (+Z axis to the left of the LO2 feedline). The divot was estimated to be approximately six inches in size (1).

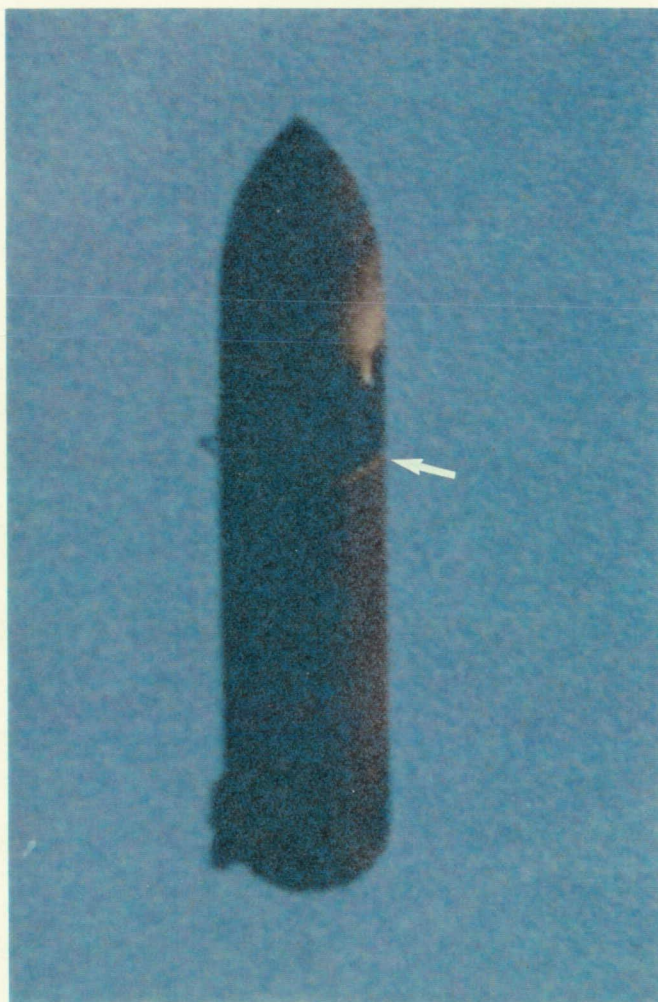
Figure 2.4.2 Possible Divots on the LH2/Intertank Interface

The detailed screening revealed two possible divots in the LH2 intertank interface on the +Y axis. The ET tumbled at approximately 0.124 revolutions per minute about a plane which intersected the optic axis. Updates to the DTO-0312 have been incorporated into the next mission's procedures that should increase the quality of the photography.

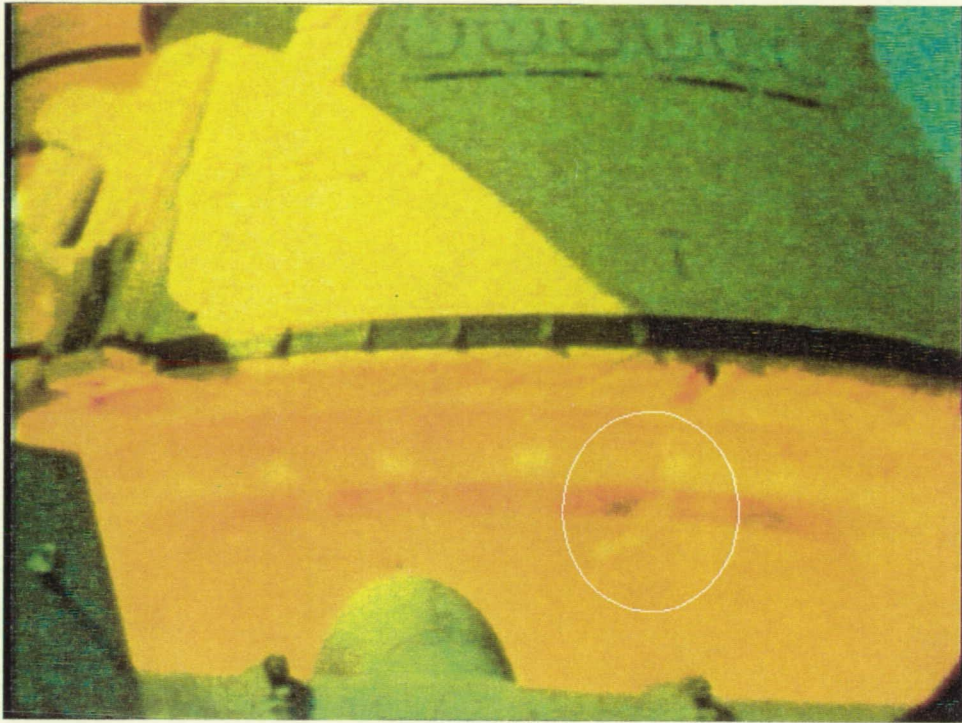
Figure 1

Loose Thermal Curtain Tape

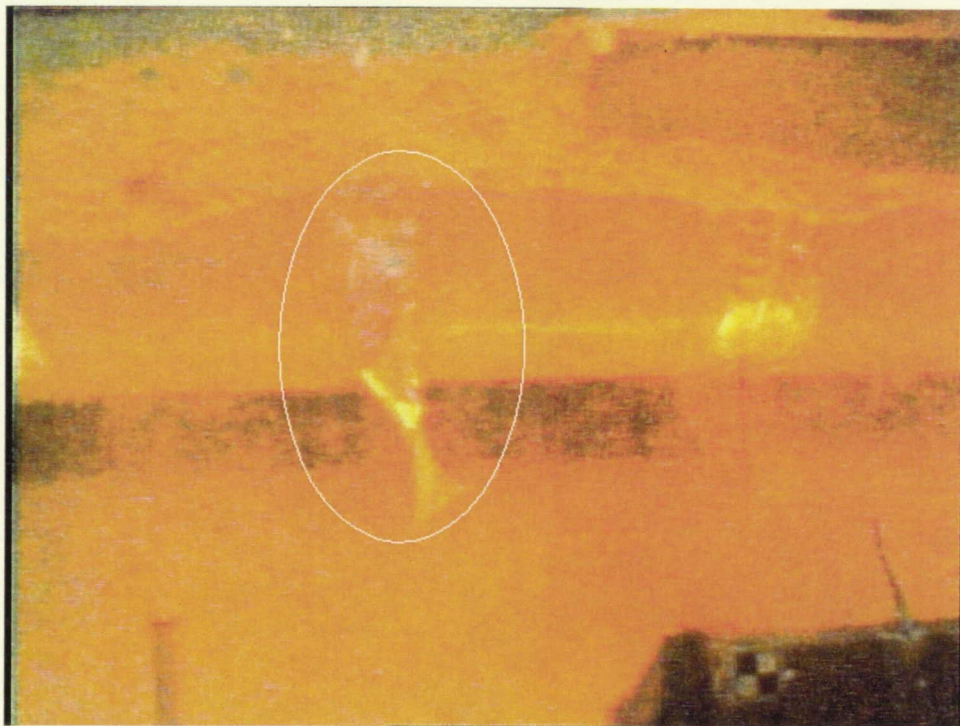
Figure 2

Loose Thermal Curtain Tape

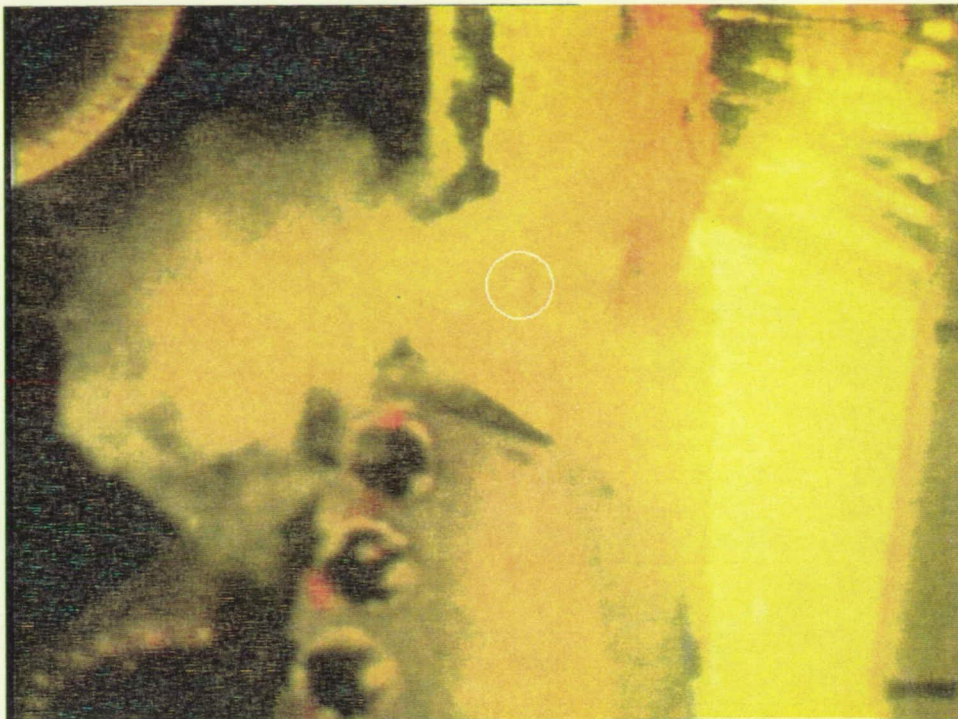
Figure 3

Debris Noted From LH2 T-0 Umbilical

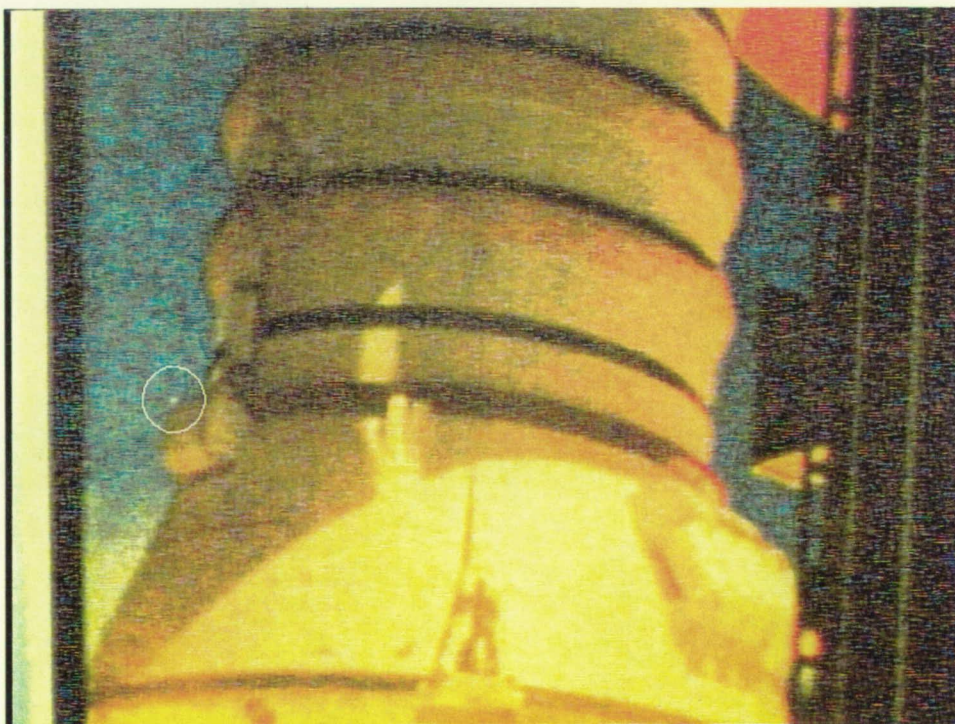
Figure 4

Pad Debris Noted From SRB Blast Hole

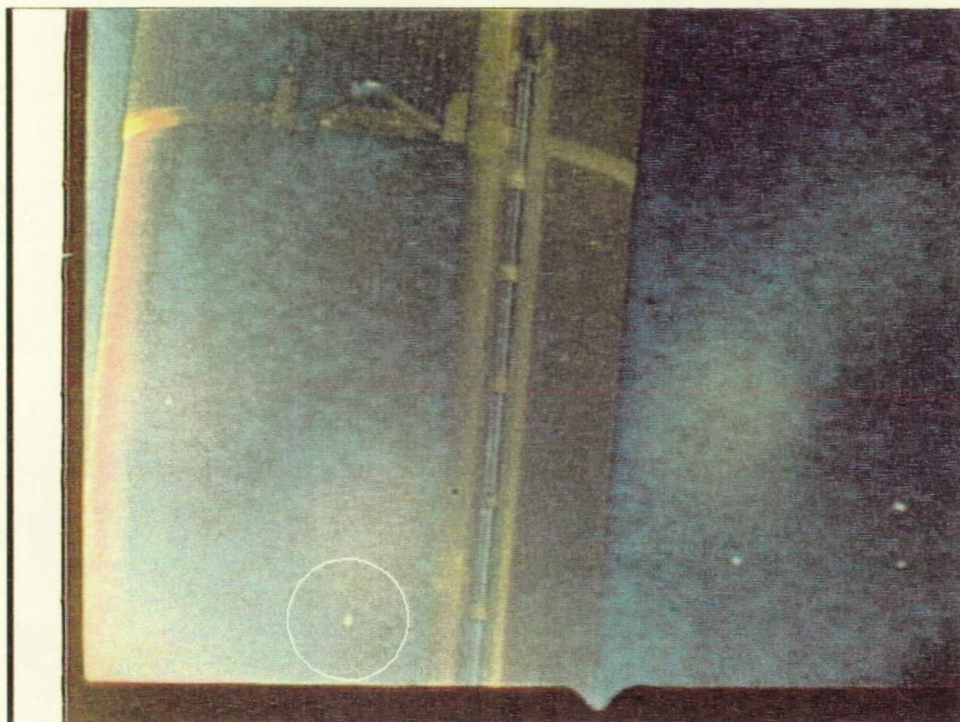
Figure 5

Divot Noted Towards Center of the LH2 Tank Near the LOX Line

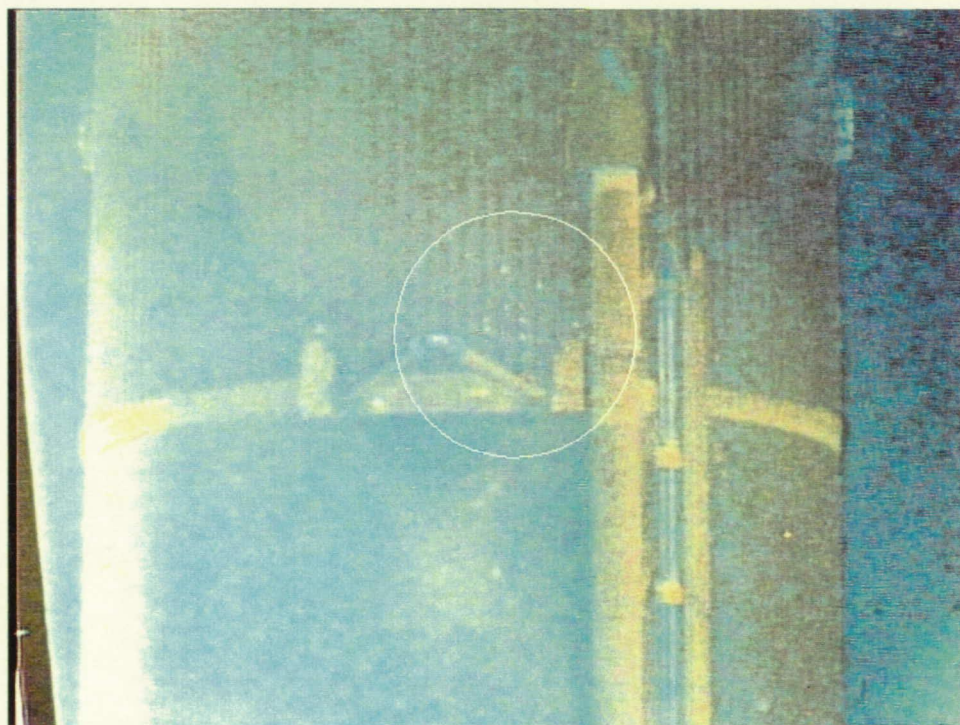
Figure 6

Several Small Divots Noted on Right Side of the Bipod on the Intertank
